REPAIR OF 140 FOOT, 150 TON, PRECISION HYDROSTATIC BEARING

**Drew Devitt, Bruce Campbell
Devitt Machinery Company and
Field Alignment Services and Training
(FAST)**

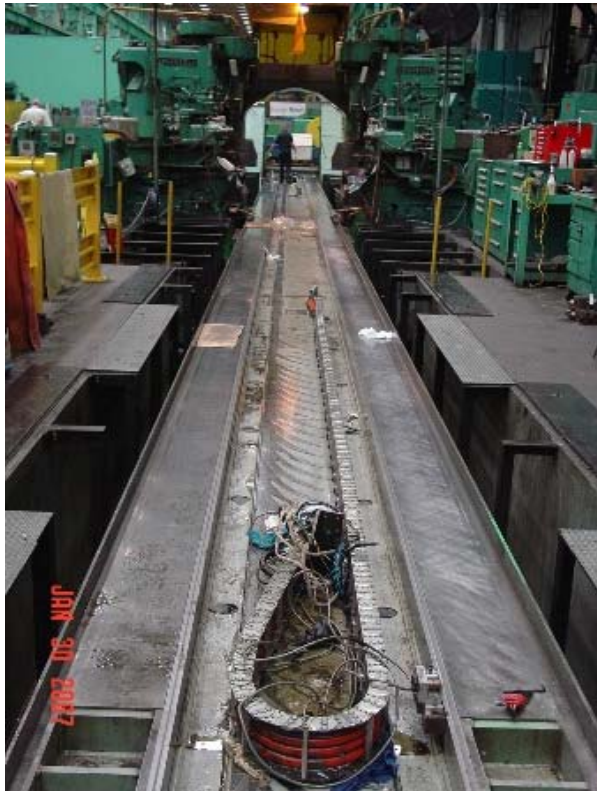
IMAGE 3. 2 ways each 12 inches wide and 140 feet long, fabricated in steel. Notice the horizontal slotting spindles

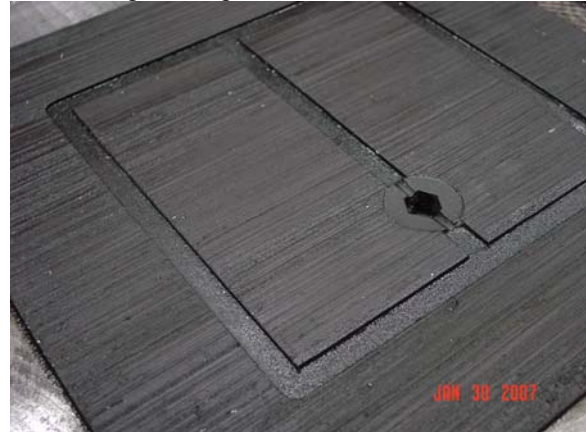
IMAGE 4

other about 40 feet long to make a 70 foot table when keyed and bolted together. The table section in illustration 1 has 60 individual hydrostatic pockets. Ingersoll had glued phonolic pads to the underside of the table. These pads had a groove milled in which follows around the inside perimeter of the plate as seen along with the scoring in image 4.

Each groove had its own small constant volume pump. So as the table is loaded and the gap gets smaller this restricts flow from the pad but the pump wants to keep the same flow and so the pressure increases re-establishing the correct gap which is .0015in by the original specification. Because the hydrostatic worm in the bed and the rack segments on the table are not simple to adjust to a different table height we wanted to keep the same table height. Approximately .030in was removed from the bed ways in the milling operation so it was necessary to remove another .030in from the phonolic bearing pads in order to have at least a .060 thickness of moldable bearing material. This was relatively simple with a router and dust collector.

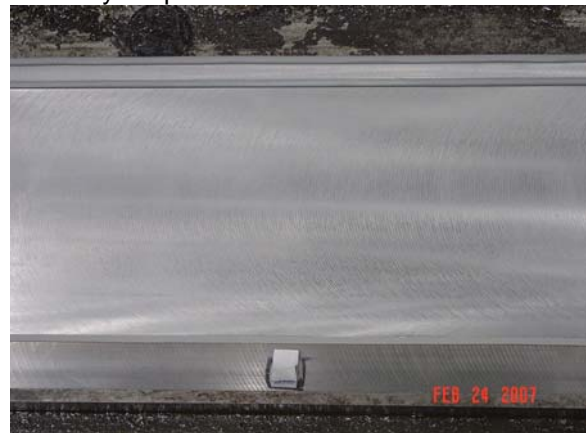
IMAGE 5

shims (see image 5) that were placed between the reference surface on the bed ways and original clearance surfaces under the table. The table was set on the bed supported by the shims placed over every other web and the alignment and worm clearance were verified. The aim is to replicate the accurate bed way surfaces by molding to them, while holding the table in its correct elevation and parallel to the bed ways. This eliminates the need to machine or scrape the table bearing surfaces.

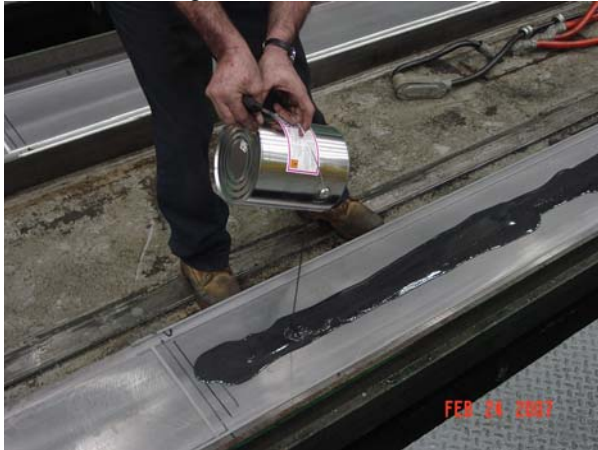
IMAGE 6

Moglice moldable bearing material will bond to the phonolic pads and fill the approximately .060in gap between the table and bed. Preparation of the bed ways includes application of release agent and the use of foam weather striping to contain the Moglice and separate the pads. The Moglice is mixed and poured on to the bed ways evenly, see image 6. The table is

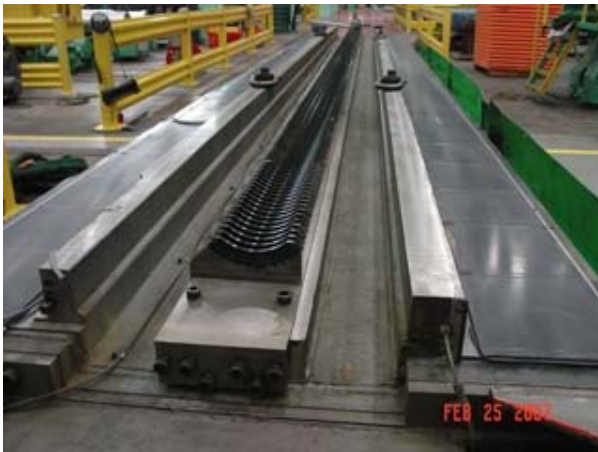
IMAGE 7 The as molded surface before trimming. Also notice that the hydrostatic worm rack segments have been replicated from a master using a moldable bearing material from the OEM

Curing of the material occurs in about 18hr so the table is left until the next morning for removal. Results of the as molded surface may be seen in image 7 and 8. The excess material is trimmed and the hydro static groves are cut in with a router and template. The second half of the table is molded in a similar fashion except that it must be matched perfectly in height so that the keyways, which have almost no clearance, engage with out lifting either table from contact with the bed. In order to achieve this easily we make sure that the first table is in place and that the way surfaces are in intimate contact with bed. We set up to pour the second table right next to the first table so that once the table has been set the keys may be engaged before curing.

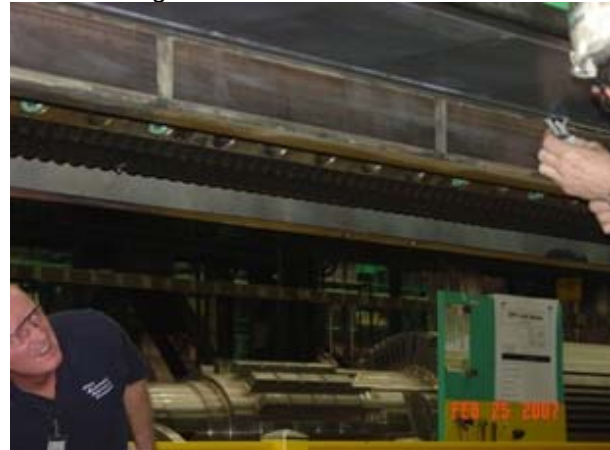
IMAGE 8 The surface immediately after release from the bed. Looking along the bottom of the image, part of a work piece cut on the machine is visible
